### I. PURPOSE

Monitoring and inspection of the Thomas disc pack in the field.

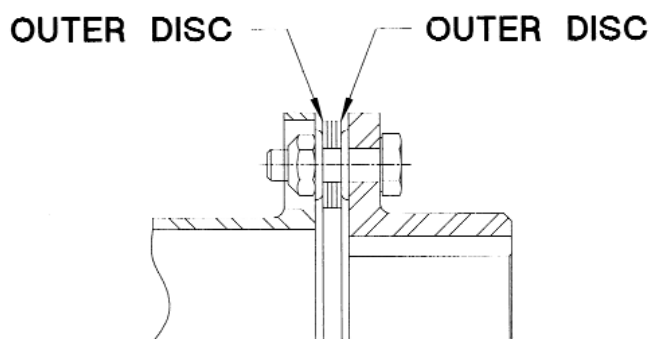
**FIGURE 1**

The Thomas disc coupling is easily inspected. Visual analysis may point to possible drive system problems. Proper evaluation of the disc packs and connecting parts may save considerable maintenance costs and downtime. When a disc coupling starts to fail, it is usually from the outer disc of the laminated pack and progresses towards the center of the pack. See figure 1.

3. Disc broken adjacent to washer face usually indicates excessive shaft misalignment during operation. See Figures 1 & 8. This type of disc failure usually starts with outer disc and progresses through the disc pack. Realign equipment and replace both disc packs. Make hot check of alignment to assure it is within coupling misalignment capacity.

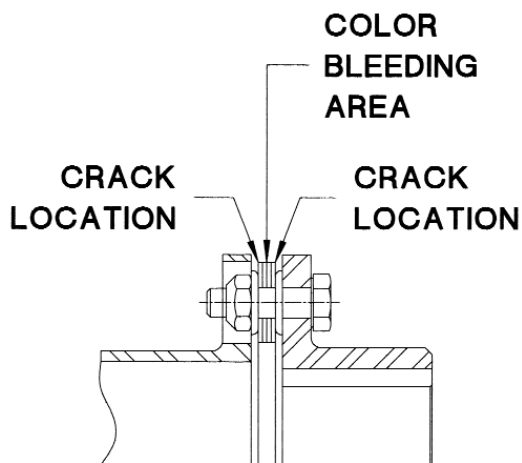
**FIGURE 2**

1. Reddish brown color bleeding out between disc laminations at the O.D. of the pack. This is an indication of fretting and/or chemical attack of the disc material. See Figure 2.
2. Fine line crack starting in the outer disc, tangent to the washer O.D. This is an indication of misalignment and can be seen by looking at the outside edge of the disc pack. See Figures 2, 8 and 9.

4. Disc broken adjacent to washer face with fretting corrosion present in the area of crack usually indicates excessive shaft misalignment during operation. Also, iron oxide will most likely be evident on outside of disc pack. See Figures 2 & 9. This is sometimes associated with a coupling that has been in service for several years and/or operating in a corrosive atmosphere. Breaks will first appear in outer discs and progress through the disc pack. Replace both disc packs and realign the equipment. Different disc pack material may also be considered.

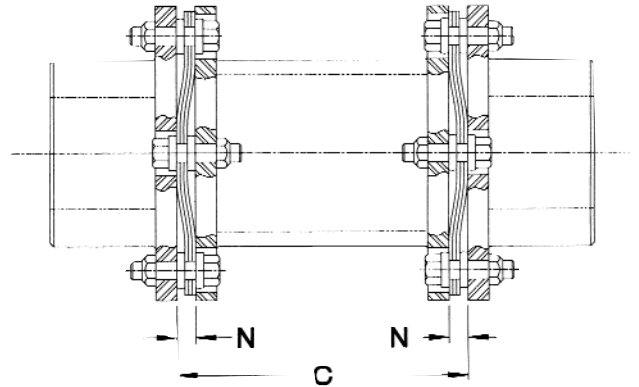
**FIGURE 3**

3. Disc pack is wavy and dimension between flange faces "N" is smaller than indicated in the installation instructions or applicable assembly drawing. See Figure 3. This indicates that the coupling has been installed in a compressed condition or equipment has shifted axially during operation. Check for shaft thermal growth conditions. Realign axial position of equipment so the coupling operates with a neutral, flat disc pack.

**COMPRESSION**

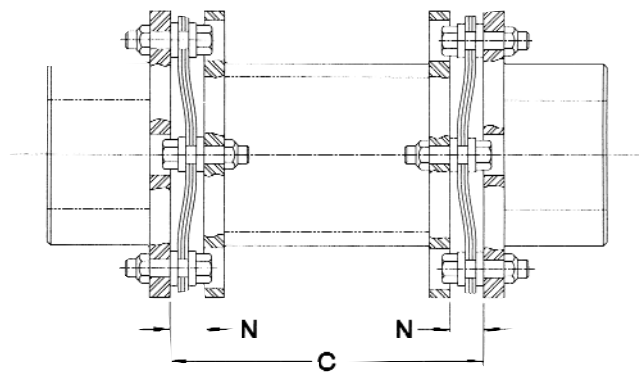
**FIGURE 4**

4. Disc pack is wavy and dimension between flange faces "N" is larger than specified on installation instructions or applicable assembly drawing. See Figure 4. This indicates that the coupling has been installed in an elongated position or equipment has shifted axially during operation. Realign axial position of equipment so coupling operates with a neutral, flat disc pack.

**ELONGATION**

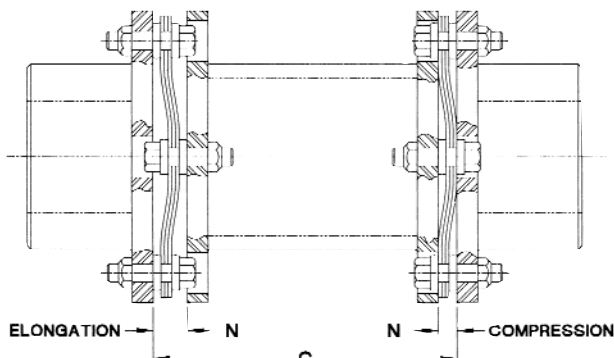
**FIGURE 5**

5. Disc packs (both ends) are wavy. One end is compressed, and the other end is elongated. (See Figure 5). The conditions can be reversed by moving the center member towards the elongated end. This is called "oil canned" disc packs. The disc pack has no neutral center where it remains flat and parallel with the end flanges.

### ***OIL CAN***

This condition can be the result of:

- 1) Tightening the disc pack locknuts while the disc packs are in the compressed or elongated coupling position. See Figure 3 and/or 4.
- 2) Tightening of disc pack locknuts while coupling is misaligned or other end of spool is hanging unsupported.
- 3) Bound up bolt(s) in the bolt hole(s).
- 4) Damaged discs which could be caused by abnormal running conditions, misuse, or loose bolts.

To correct "oil canned" disc pack:

- 1) Loosen all the disc pack locknuts. Correct the axial spacing of the coupling as necessary with the coupling aligned and spacer fully supported. If "oil canned" conditions disappears, retorque locknut while coupling is in its neutral position.
- 2) If (1) above is not successful, determine that all bolts, with locknuts loose, can be turned by hand. If any bolts are tight, the bolt holes should be cleaned out by lightly reaming the flange so that the bolt turns by hand in the hole. Reassemble and torque the locknuts while coupling is in its neutral position.

- 3) If the discs in the pack are permanently deformed, replace the disc pack with a new one and reassemble the coupling. This permanent deformation could be caused by a severe torque overload, abnormal axial loads, or even loose bolts. The cause of the deformation must be corrected before restart.

The coupling, as finally assembled, should have a neutral center where the center member is free to float axially with out snapping from one end to the other when moved by hand.

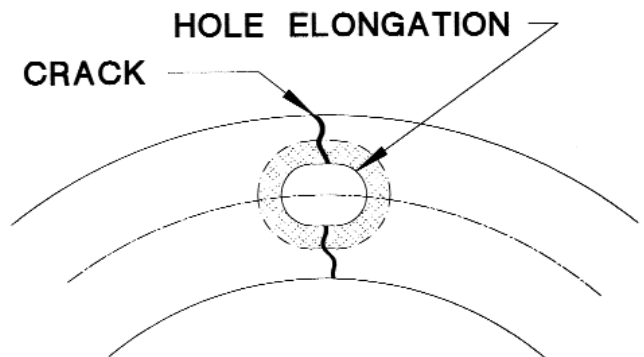
**FIGURE 6**

1. Disc broken through the bolt hole indicates loose coupling bolts. See Figure 5. Replace disc pack and tighten locknuts to specified torque value.

### ***LOOSE BOLTS***

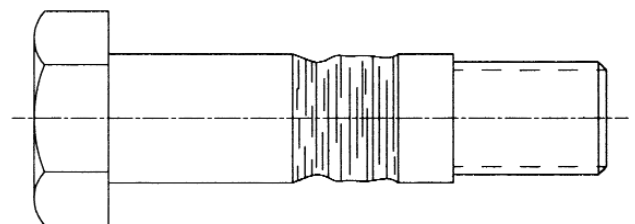
**FIGURE 7**

2. Discs embedded into bolt body are usually the result of a loose bolt or a severe torque overload. See Figure 7. Replace bolt and disc pack. Tighten locknut to proper torque. Do not torque the bolt as insufficient bolt stretch may occur.

### ***LOOSE BOLTS***

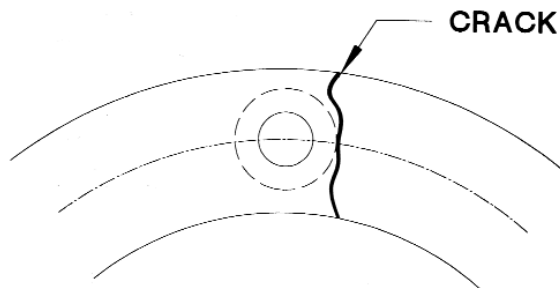
**FIGURE 8**

### **EXCESSIVE MISALIGNMENT**

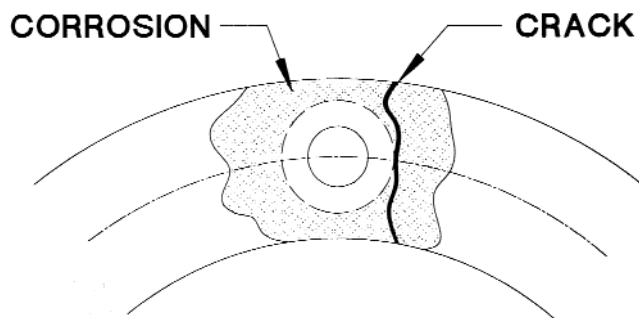
**FIGURE 9**

### **EXCESSIVE MISALIGNMENT WITH CORROSION**

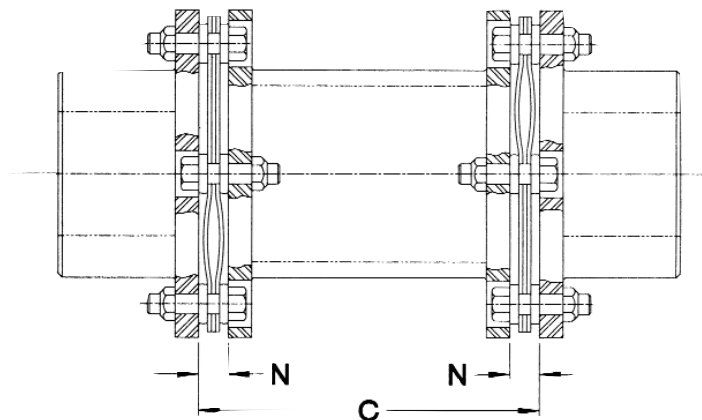
**FIGURE 10**

5. The disc pack has a bulge near the center or is bowed toward one flange in alternate chordal sections. See Figure 10. This condition is a result of a large torque overload, induced into the system, beyond the peak overload capacity of the coupling. The remaining disc pack chordal sections will be straight and tight. This indicates improper coupling selection or a momentary system torque overload. If bulged or bowed conditions appears in one chordal section only, there may be a loose bolt on one side of the distortion. Loosen all coupling locknuts and unseat the bolts. The bulge should release and flatten out. Retorque locknuts. If distortion does not disappear, replace disc pack and retorque locknuts.

### **TORQUE OVERLOAD**
