MOTOR CURRENT SIGNATURE ANALYSIS TO DETECT FAULTS IN INDUCTION MOTOR DRIVES—FUNDAMENTALS, DATA INTERPRETATION, AND INDUSTRIAL CASE HISTORIES

William T. Thomson

Ronald J. Gilmore

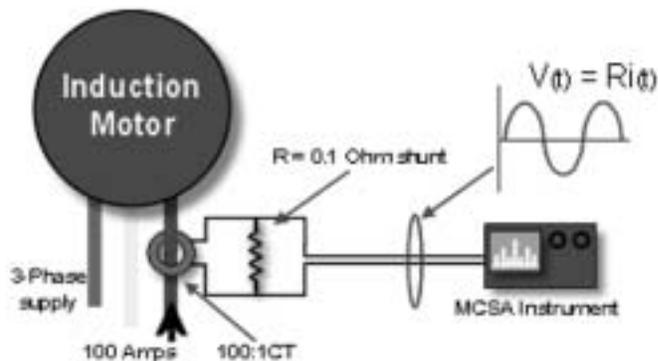
Figure 1. Basic MCSA Instrumentation System.

- A current transformer (CT) to sense the signal.
- A resistive shunt across the output of the CT—note that CTs are available with internal shunts.
- An MCSA instrument (or spectrum analyzer) to produce the current spectrum or signature.

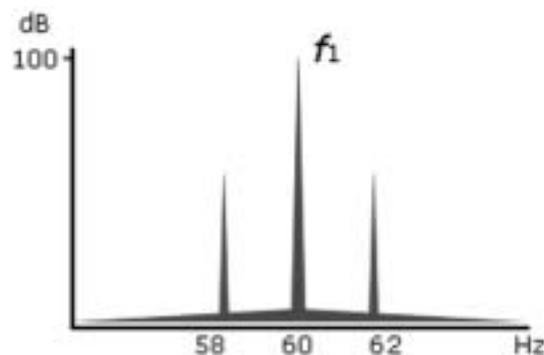
Figure 2. Illustration of Current Spectrum.

An idealized current spectrum is shown in Figure 2 that, in this illustration, represents the twice slip frequency sidebands due to broken rotor bars. Note that a decibel (dB) versus frequency spectrum (referred to as linear root-mean-square (rms)) is used to give a wide dynamic range and to detect the unique current signature patterns that are characteristic of different faults. Depending on the actual onsite installation, the CT can be of two types, namely a clip-on CT around one of the phases of the supply cable as shown in Figure 3, or around the secondary side of an existing instrumentation CT in the instrumentation panel as shown

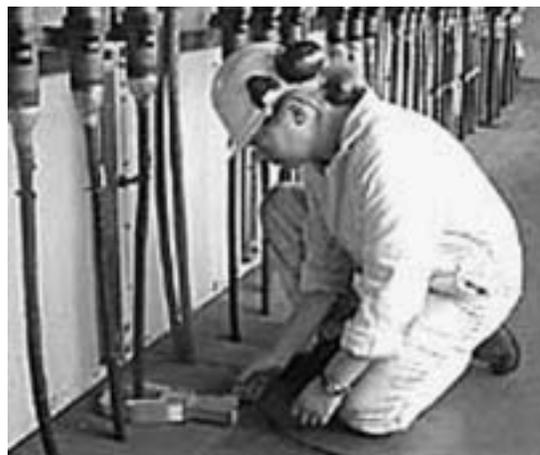
Figure 3. Clip-on CT Around Supply Cable.

Since a question on CT specifications was raised at the 2002 Symposium, here is a typical specification for a commercially available CT that has been successfully used for MCSA:

- Input current range: 1 A to 600 A
- Accuracy: ± 2 percent of reading 50 Hz to 1 kHz; ± 3 percent of reading, 30 Hz to 50 Hz and 1 kHz to 10 kHz
- Working volts: 750 V, AC rms maximum. Maximum conductor size: 2 inches (50.8 mm)

The high frequency response is required to cover the frequency range of components that can be induced due to different fault mechanisms found in a wide range of designs of three-phase induction motors and also to cater for inverter fed (variable speed) induction motor drives. If necessary, more technical details on in situ instrumentation CTs and clip-on CTs of the type shown in Figures 3 and 4 will be provided at the actual tutorial presentation.

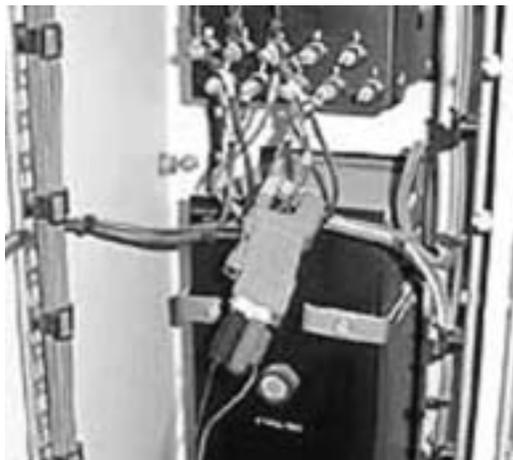
Figure 4. Small Clip-on CT Around the Secondary of Existing Instrumentation CT.

in Figure 4. Note that only one CT is required for MCSA, and it can be in any one of the three phases. The fundamental reason for this is that the rotating flux waves produced by the different faults cut all three stator phase windings, and corresponding currents are induced in each of the three phases.

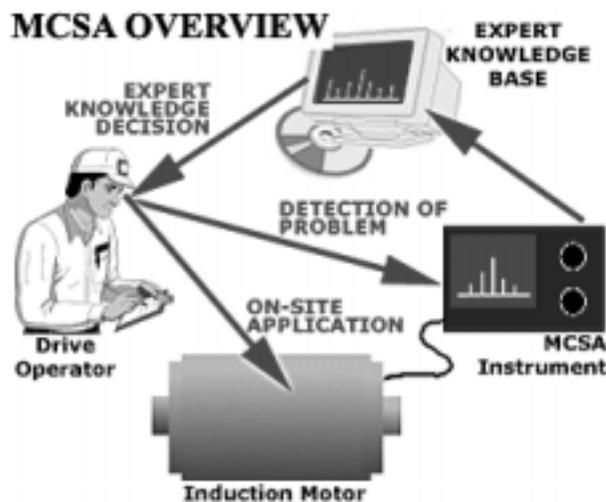
Figure 5. Overall MCSA Strategy.

Figure 5 illustrates the key elements for the successful application of MCSA, these include:

- Fundamental understanding of the design and operation of three-phase induction motors.
- MCSA instrument (or spectrum analyzer) to present the signature patterns.
- Expert knowledge base via expertise within the user's organization and/or external consultants.
- Finally it is the drive operator who has to make the final decision to either immediately remove the motor for repair or let it run and prepare for a planned outage to rectify the problem.

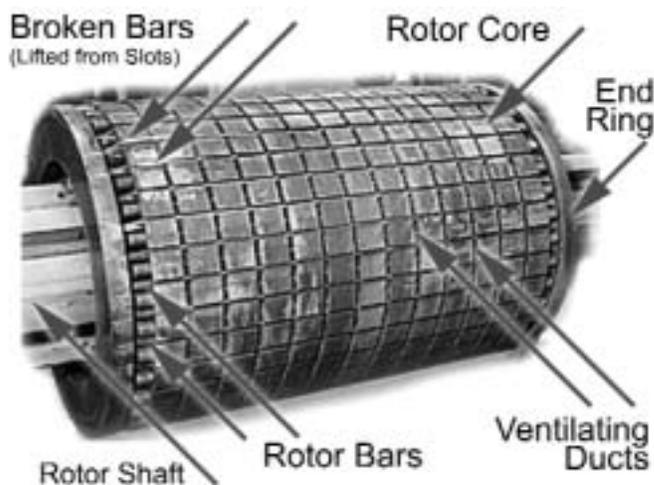
Figure 6. Example of Broken Rotor Bar Problem.

The specification of the measurement to present the current spectra for different fault mechanisms is a key feature, but this can only be done from an understanding of three-phase induction motors and the signature patterns that are produced by specific faults. Figure 6 is an example of a broken rotor bar problem.

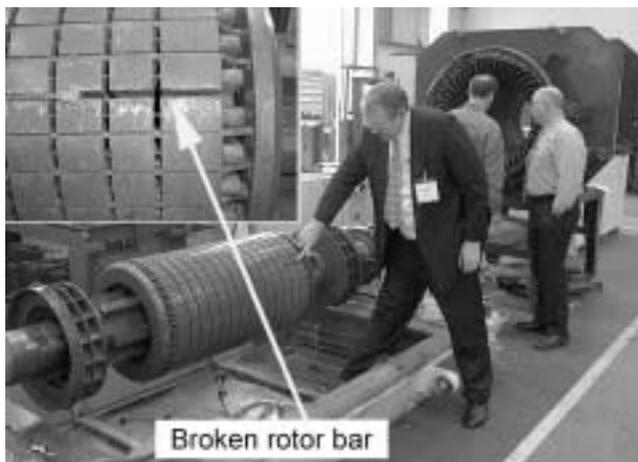
Figure 7. Broken Rotor Bar Lifted out of the Slot.

winding failure may follow, resulting in a costly repair and lost production. Figure 7 shows a case where a broken rotor bar had lifted in the slot, and the resultant damage to the high voltage stator winding is shown in Figure 8. (Figures 7 and 8 refer to a three-phase, 11 kV, 2900 kW (3887 hp), 179 A, 50 Hz, 2978 rpm, squirrel-cage induction motor (SCIM).)

The repair cost was \$160,000 for a replacement rotor and a complete rewind of the stator winding. Fortunately there was a dual drive train to deliver the process on the offshore oil production platform, but this is not always the case since single drive trains are now more common to reduce capital cost, weight, and size of offshore oil production platforms. In hazardous environments, sparking at the fault site during the degradation process can be a potential safety hazard. Operators of large high voltage induction motors cannot take unnecessary risks, hence MCSA is now being extensively used to assess the operational condition of rotor cage windings.

It will now be shown how MCSA avoided the type of problems that had previously occurred and are shown in Figures 7 and 8. Failure of this crucial motor was prevented.

The broken bar factor = 0.79, but Equation (3) is for full-load operation and this has to be corrected since the MCSA measurement was taken on reduced load. Applying the correction factor for this load and particular motor design (commercially sensitive and cannot be released), then the broken bar factor is: n = 1.15. It was therefore predicted that there was definitely one bar completely broken. There was also a risk of the broken bar lifting out of the slot with consequential mechanical damage to the HV stator winding and failure as was illustrated in another case as shown in Figures 7 and 8.

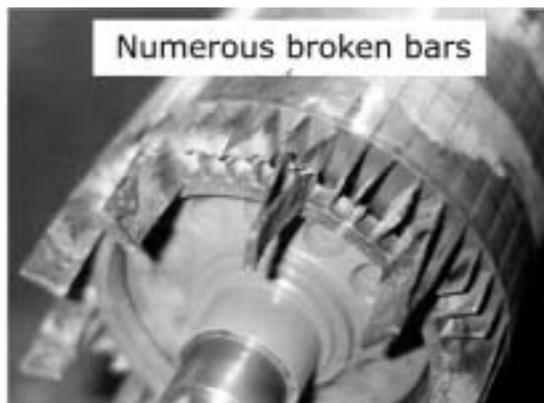
Figure 9. Crane Motor—Broken Rotor Bars.

Additional examples of broken rotor bar failure are shown in Figures 9 and 10. The rotor in Figure 9 was from a crane motor subjected to DOL starts and had a long run up time (45 sec!). This rotor was not fit for purpose and was not producing sufficient starting torque for the load starting condition. Note the narrow bars and the classic crescent-shape breaks of the actual bars. Figure 10 shows a rotor from a food mixer motor that was being subjected to 24 starts per hour, which again was just too arduous a duty cycle for the rotor design. New designs were implemented and the problems were eliminated.

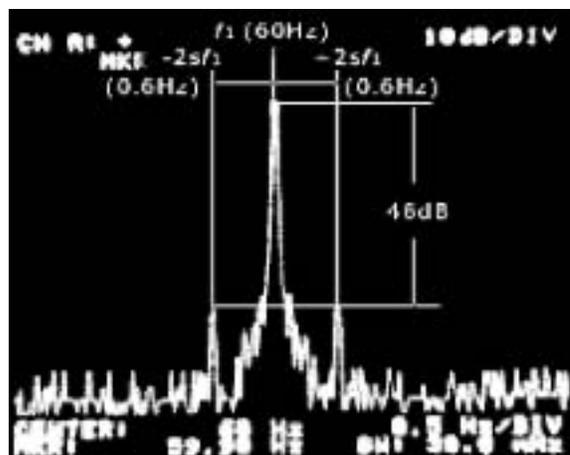
Figure 11. Current Spectrum—Healthy Rotor.

Motor nameplate data: three-phase, SCIM, 6600 V, 3.6 MW/4285 hp, 60 Hz, 376 A, 3580 rpm, star connected. The rotor was copper fabricated, single cage, nose joint design between bars to end ring, 46 rotor bars. The first step is to calculate the full-load slip: $s_{fL} = (3600 - 3580)/3600 = 0.0055$. (Refer to APPENDIX A for explanation and definition of slip in an induction motor.) Note that this large motor has a low full-load slip value of 0.0055 or 0.55 percent. Figure 11 is an FFT zoom current spectrum from a routine survey using MCSA. When the motor is operating at full-load current, then the predicted twice slip frequency sidebands for a nameplate frequency of 60 Hz and a full-load speed of 3580 rpm are ± 0.66 Hz.

Examination of Figure 11 shows that there are sidebands at ± 0.6 Hz around f_1 the supply frequency that was 59.9 Hz and not 60 Hz. The measured sidebands therefore correspond to within less than 10 percent of the predicted values using full-load nameplate data since the motor was actually operating at full-load current. In Figure 11 the sidebands are greater than 45 dB down on the supply current, and this corresponds to a healthy working unit for a two-pole motor of this design and rating having 46 rotor bars. Although there are sidebands, it means the rotor is not perfect and there is some rotor asymmetry due to inherent differences in the bar to end ring joints.

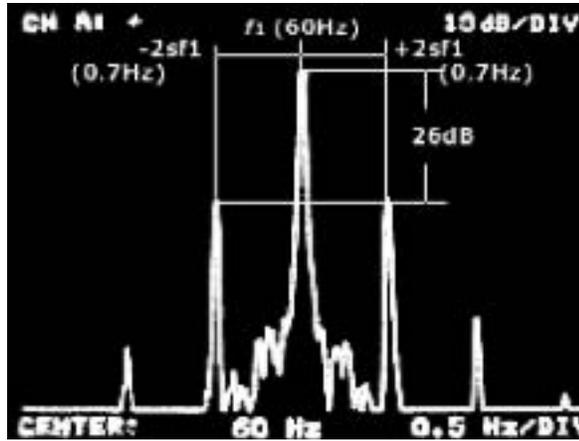
Figure 12. Current Spectrum—Broken Bars.

Due to the incident that occurred, MCSA was applied to assess the condition of the rotor winding. Figure 12 shows the current zoom spectrum and the twice slip frequency sidebands are at ± 0.7 Hz. The dB difference between the sideband magnitudes and the supply frequency component is now 26 dB, and this is indicative of a serious broken rotor bar problem. In comparison to Figure 11, the magnitude of the sidebands has increased by 20 dB, which is a factor of 10 times larger in the absolute units of amps.

The recommendation was that the motor should be immediately removed from service since the rotor cage winding was in an extremely unhealthy state. It was a high voltage motor operating on an offshore oil production platform and secondary damage to the motor was a possibility, plus the safety implications had also to be considered. The motor was immediately removed from service, and Figure 13 shows an actual photo of the faulty rotor. As predicted, there were numerous broken rotor bars. There were in fact 20 broken bars.

Please note that MCSA can be applied at any time and a previous result is not required for comparison. A dB difference of 26 dB from a one-off measurement, as shown in Figure 12, equates to a serious broken rotor bar problem.

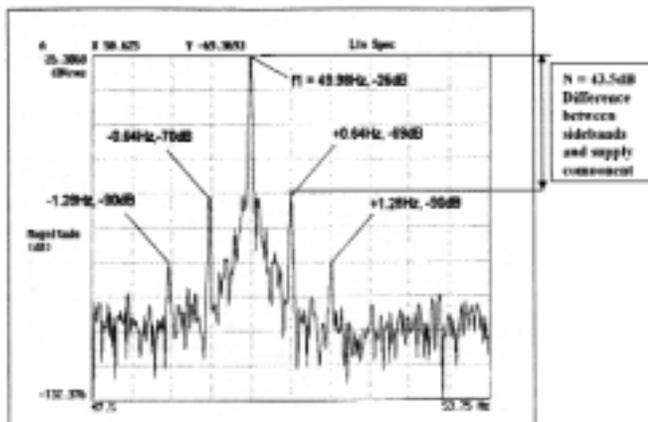
Figure 14. Current Spectrum (or Signature)—Strategic LP Compressor Motor.

given in step five. Note: use a dB (V rms) instead of a power spectrum since the supply component of current can then be calculated to validate the current signal being analyzed. Figure 14 shows the current spectrum.

There are sidebands at ±0.64 Hz around the supply frequency (49.98 Hz). These are the twice slip frequency sidebands due to a broken rotor bar problem for this motor when operating at a reduced load (104 A) compared to the full-load current of 120 A. It has been proven via numerous case histories that the dB difference (N) between the sidebands and the supply component can be used to estimate the severity of the broken rotor bar problem. The operators had to avoid secondary damage to the stator winding (refer to Figures 7 and 8 for an example), and the crucial questions to be answered were:

- n = Estimate of number of broken bars
- R = Number of rotor slots
- N = Average dB difference between upper and lower sidebands and supply component = (43 + 44)/2 = 43.5
- p = Pole-pairs = 2

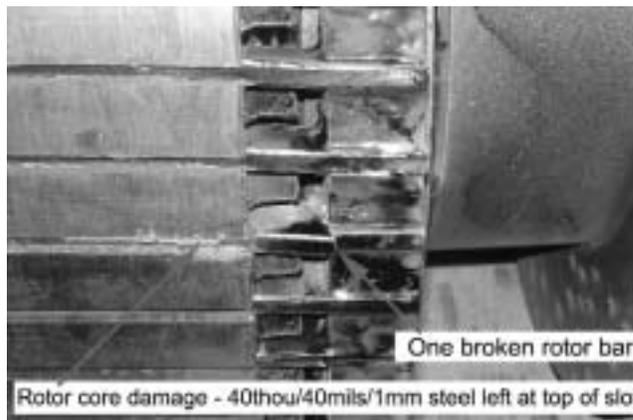
Figure 15. Faulty Rotor Winding Diagnosed via MCSA—Prevented Secondary Damage to HV Stator Winding.

The motor was regularly monitored to trend any further deterioration. A new rotor was immediately ordered, and a spare one was

located in storage. The spare one was refurbished by the manufacturer since it had been in storage for 14 years. The faulty rotor was removed and the replacement one installed with a total planned outage of five days on the offshore oil and gas production platform. Note that special scaffolding had to be constructed, etc., for removal of the rotor within the modular construction. Inspection of the faulty rotor, as shown in Figure 15, proved that the diagnosis was correct and that there was one completely broken rotor bar. In fact there was only 40 thou/40 mils/1 mm of laminated steel left at the top of the slot, and note the damage to the rotor core. There was a very high risk of the broken bar lifting out of the slot with consequential mechanical damage to the HV stator winding and a very lengthy outage as previously discussed.

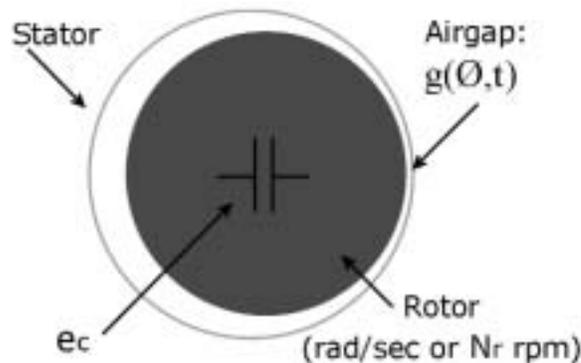
Figure 16. Illustration of Airgap Eccentricity.

Airgap eccentricity consists of two types, which exist simultaneously in a real SCIM due to manufacturing tolerances/installation procedures (in large motors). First there is static eccentricity, where the position of minimum radial airgap length is fixed in space. It can be caused by stator core ovality or incorrect positioning of the rotor or stator. There is always an inherent level due also to manufacturing tolerances caused by the compound buildup of parts that have their own tolerances. Second there is dynamic eccentricity, where the minimum airgap revolves with the rotor and is a function of space and time. This can be caused by a nonconcentric outer rotor diameter, thermal bowing of the rotor, or bearing wear and movement. The airgap eccentricity specified by a manufacturer is the radial airgap eccentricity (static plus dynamic) and is normally given as a percentage (e%) of the nominal radial airgap length (g). An illustration of airgap eccentricity is shown in Figure 16.

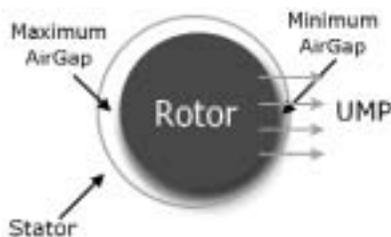
Figure 17. Illustration of UMP.

Static eccentricity causes a steady force called unbalanced magnetic pull (UMP) on the rotor in one direction that tries to pull the rotor even further from the stator bore center in the direction of the minimum airgap as shown in Figure 17. The resistance to this further reduction in the airgap is primarily controlled by the mechanical stiffness of the rotor. Flexible rotors are therefore more prone to rotor to stator rubs due to high UMP.

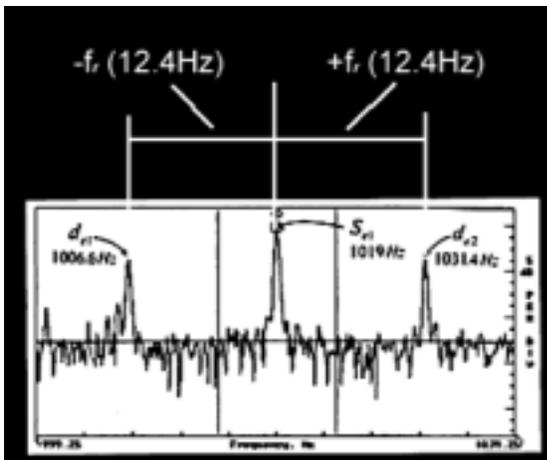
Figure 18. Current Spectrum, Unacceptable Level of Airgap Eccentricity.

Motor nameplate data: three-phase, 11 kV, 1.45 MW/1944 hp, 103 A, 742 rpm, 50 Hz, star-connected, no parallel paths in the stator winding. The rotor slots, $R = 62$. Four motor-pump drives are used to pump oil from an oil tank farm into large tankers in a nearby deep water estuary. One of the motors had developed a bearing vibration and temperature problem and would only run for 45 minutes since it tripped out on a high bearing temperature of 180°F (85°C). The fundamental cause of the problem could not be determined via vibration analysis. MCSA was applied to determine whether there was an airgap eccentricity problem. Figure 18 shows a portion of the current spectrum (from the faulty motor) with one of the rotor slot passing frequency components (S_{e1}) and the components (d_{e1} , d_{e2}) corresponding to $n_d = \pm 1$ from Equation (5). The signature pattern is characteristic of a motor with an abnormal level of airgap eccentricity. The d_{e1} and d_{e2} components are the same magnitude, namely, 15 dB down on the rotor slot passing frequency S_{e1} for the problem motor. But, in an identical and healthy motor, the d_{e2} component is not present, and the d_{e1} component is 25 dB down on the rotor slot passing frequency component (S_{e1}) as shown in Figure 19 compared to the faulty one shown in Figure 18. The signature pattern in the problem motor is exhibiting the characteristic pattern of a motor with an unacceptable level of airgap eccentricity, namely that both the plus and minus rotational speed frequency components around the rotor slot passing frequency are clearly evident and 15 dB down on S_{e1} . For normal airgap eccentricity levels, the d_{e1} and d_{e2} components should both be greater than 25 to 30 dB down on S_{e1} .

This motor had a nominal airgap length of 100 thou or 2.5 mm, and the manufacturer allowed a tolerance of ± 5 percent (± 5 thou) airgap eccentricity (total of static plus dynamic). The rotor was manufactured to have a total run out of 2 thou or 0.05 mm giving a dynamic eccentricity of just 2 percent. The motor airgaps were checked onsite and were found to be 35 percent and 20 percent at the drive-end and nondrive-end, respectively. It was removed to the manufacturer’s workshop, where the rotor runout was checked and was found to be as per the original specification at the time of manufacture. It should be appreciated that although the offline checks gave an airgap eccentricity of 35 percent, this could be higher when the motor was running due to UMP and, of course, could result in

a higher dynamic eccentricity, due to any bow in the rotor as a by-product of the high static airgap eccentricity. The problem was primarily high static airgap eccentricity, and the motor was reassembled and installed to ensure the overall airgap eccentricity level was not greater than ± 10 percent of the nominal airgap length. The high bearing temperature and vibration problem was eliminated, which proved that MCSA had identified the root cause of the initial problem.

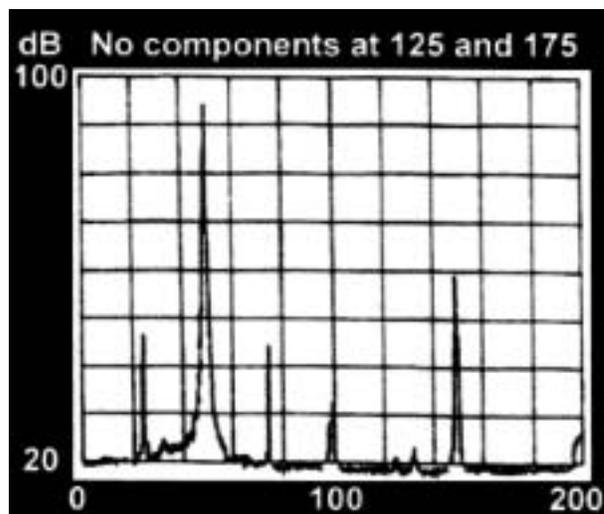
Figure 20. Current Spectrum—Healthy Stator.

Results from an 11 kW, 415/420 V, 20.5 A, 1440 rpm, 50 Hz, SCIM, delta connected motor are now reported. The stator winding was a three tier concentric winding with random wound coils in 36 slots. There were two coils per group, four groups per phase, and each group had coils of 15 and 30 turns, respectively, giving 180 turns per phase. Figures 20 and 21 show the current spectra with no fault and the case with actual shorted turns. The components that are clearly indicative of shorted turns under no-load are 125 Hz and 175 Hz, as per Equation (6), with $k = 1$, $n = 3$, and $k = 1$, $n = 5$. Note that the components at 25 Hz and 75 Hz are present under normal operation (the \pm rotational speed frequency components) and cannot be used as indicators of shorted turns even although

they are predicted from Equation (6). There are no current components at 125 and 175 Hz (no-load slip is approximately zero for Equation (6)) with no stator fault, but they are very evident at 56.6 and 42.3 dB, respectively, in the case with direct shorted turns. Thomson (2001) has shown that these components could also be detected at 27.7 and 23.6 dB, respectively, with one shorted turn via a current limiting resistor to avoid initial burnout.

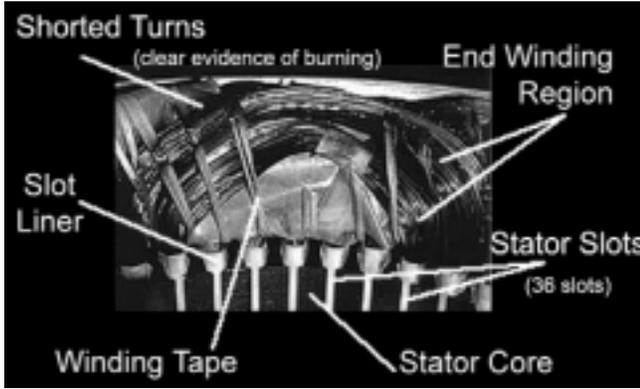
Figure 22. Faulty Stator Winding Diagnosed via MCSA.

Figure 22 shows the faulty stator winding. This demonstrates that these two components are good indicators for detecting shorted turns in four-pole SCIMs with random wound, concentric coils. Note that these components will change in frequency as a function of load and speed, as reported by Thomson (2001). Note that a continuous MCSA system must be used to detect shorted turns.

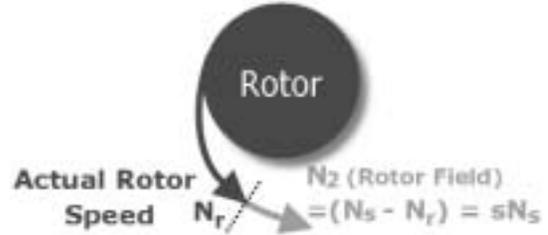
Figure A-2. Illustration of Rotating Field from Rotor Currents Moving Faster than Rotor Speed.

- Under normal operation, the rotating magnetic field produced by the currents flowing in the rotor conductors moves faster than the actual rotor speed (N_r), as illustrated in Figure A-2.

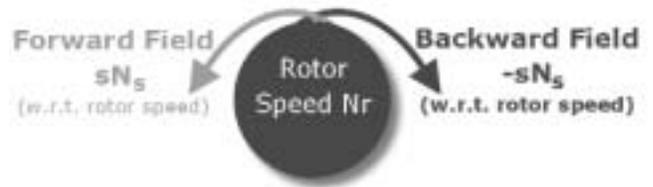
Figure A-3. Illustration of Forward and Backward Rotating Fields from Rotor Currents When a Broken Bar Exists.

With broken rotor bars there is an additional rotating magnetic field produced. Broken rotor bars produce a backward rotating field at slip speed (-ve direction $(N_s - N_r) = sN_s$) with respect to the rotor as illustrated in Figure A-3.
